# Aging Transport Systems Rulemaking Advisory Committee

Task 3

Final Report (2<sup>nd</sup> draft)

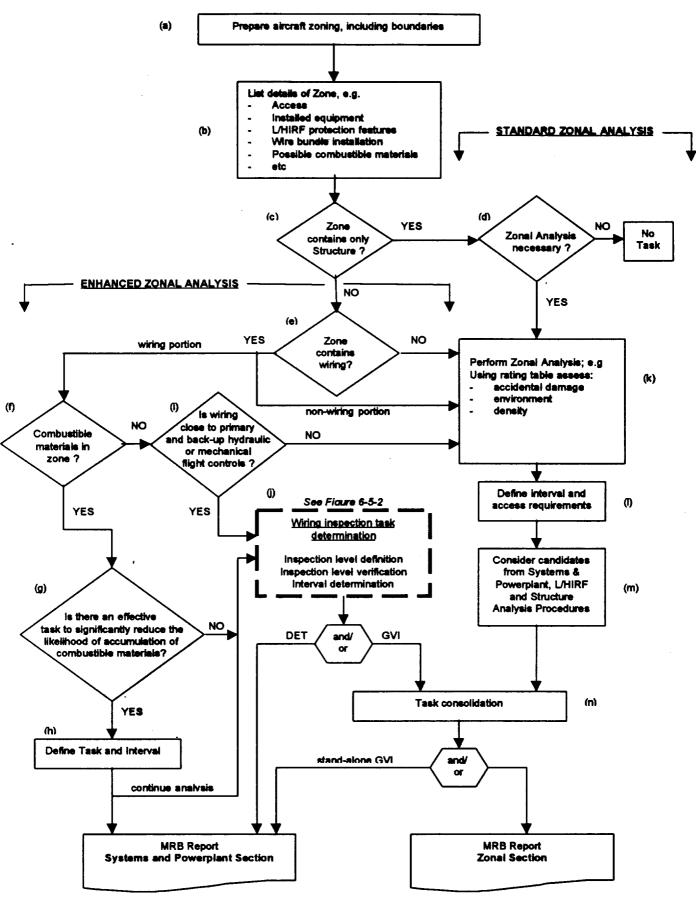
# Zonal Analysis Procedure Figure 6.5.1

The logic diagram developed (see Figure 6.5.1) was concluded to be suitable to determine:

Note that figures 2-5-2.1 and 2-5-2.2 are equivalent to figures 6.5.1 and 6.5.2 in this Report with the exception that figure 2-5-2.1 does not include the question (i) relating to proximity of wiring to flight control systems.

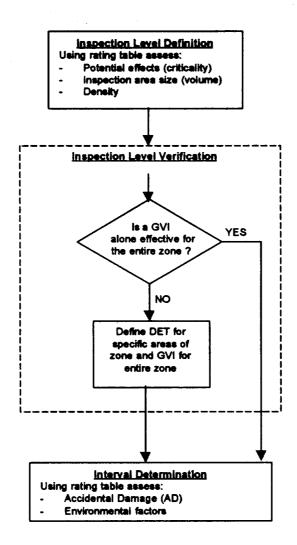
Figure 6.5.2 (see figure 6.5.1 for higher level)

#### Wiring inspection task determination

The following paragraphs provide further explanation of each step in the logic.

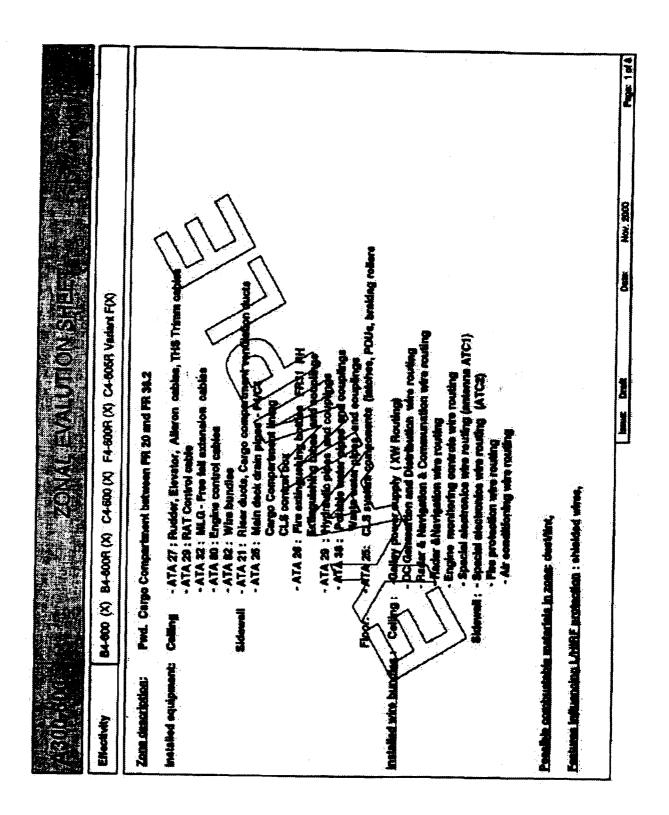
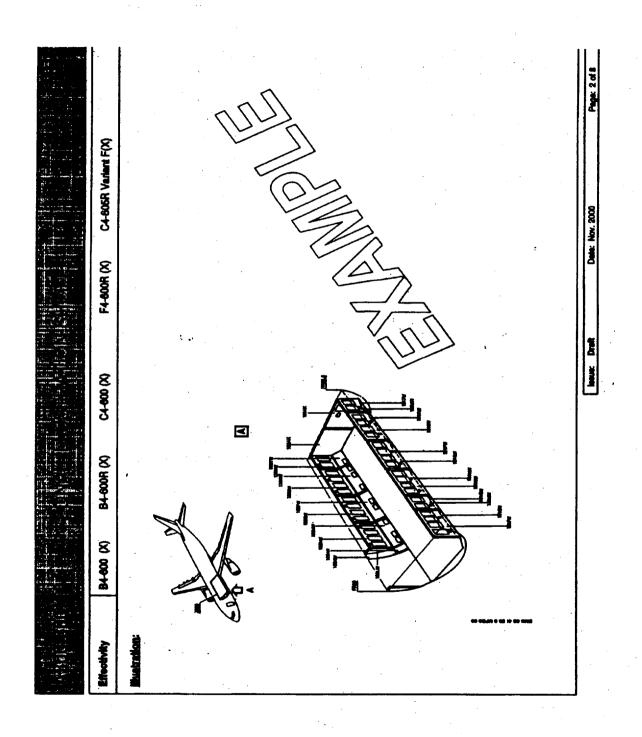
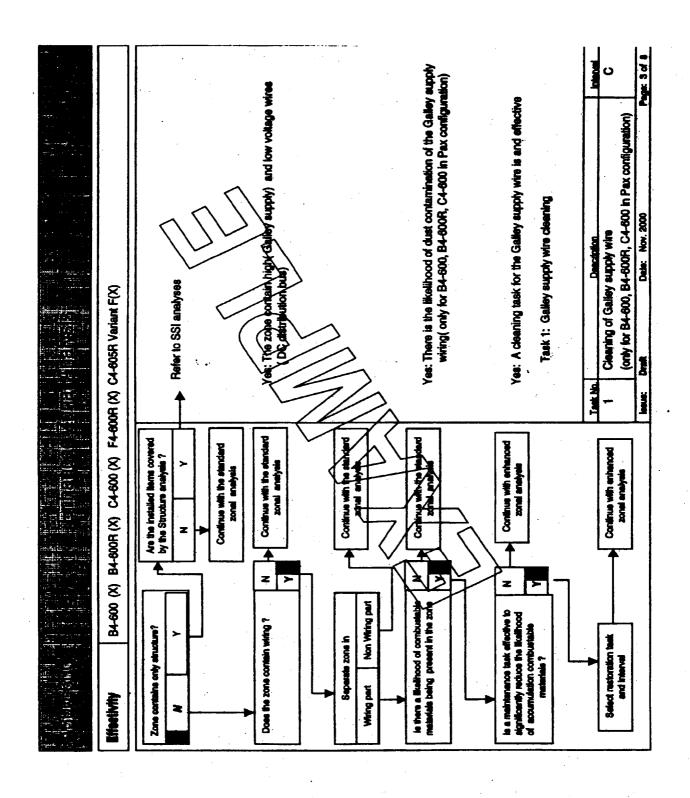
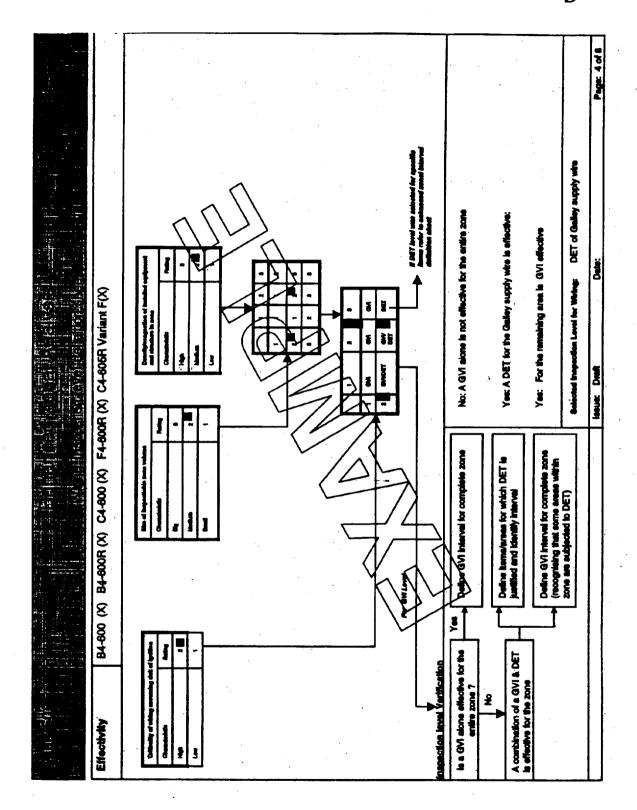
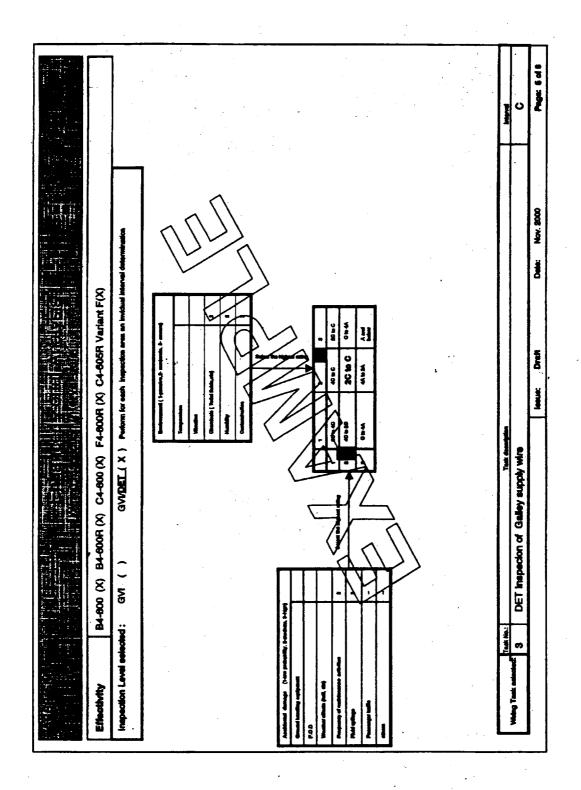
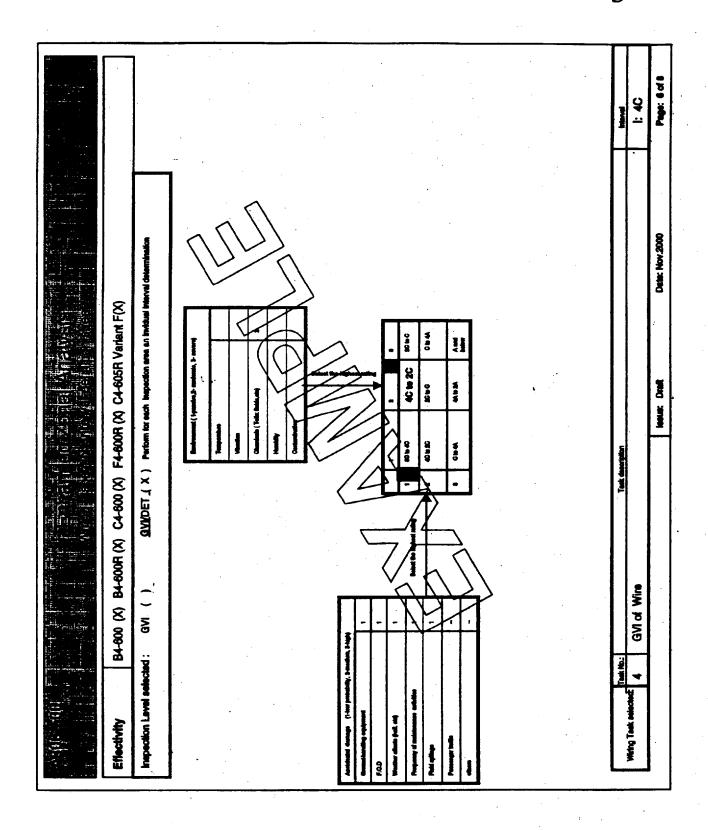
These are examples developed by the OEM's Task 3SC representatives for the purpose of substantiating the logic procedure. Neither the OEM's designated task development team nor a Zonal Working Group has reviewed them and thus the results should not be considered as a recommendation.
